**DEPARTMENT OF TRANSPORTATION****DIVISION OF ENGINEERING SERVICES**

Quality Assurance and Source Inspection

Contract #: 04-0120F4Cty: SF/ALA Rte: 80 PM: 13.2/13.9File #: 1.28**WELDING INSPECTION REPORT****Resident Engineer:** Casey, William**Address:** 333 Burma Road**City:** Oakland, CA 94607**Report No:** WIR-026728**Date Inspected:** 15-Nov-2011**Project Name:** SAS Superstructure**OSM Arrival Time:** 700**Prime Contractor:** American Bridge/Fluor Enterprises, a JV**OSM Departure Time:** 1730**Contractor:** American Bridge/Fluor Enterprises, a JV**Location:** Jobsite**CWI Name:** As noted below**CWI Present:** Yes No**Inspected CWI report:** Yes No N/A**Rod Oven in Use:** Yes No N/A**Electrode to specification:** Yes No N/A**Weld Procedures Followed:** Yes No N/A**Qualified Welders:** Yes No N/A**Verified Joint Fit-up:** Yes No N/A**Approved Drawings:** Yes No N/A**Approved WPS:** Yes No N/A**Delayed / Cancelled:** Yes No N/A**Bridge No:** 34-0006**Component:** SAS OBG**Summary of Items Observed:**

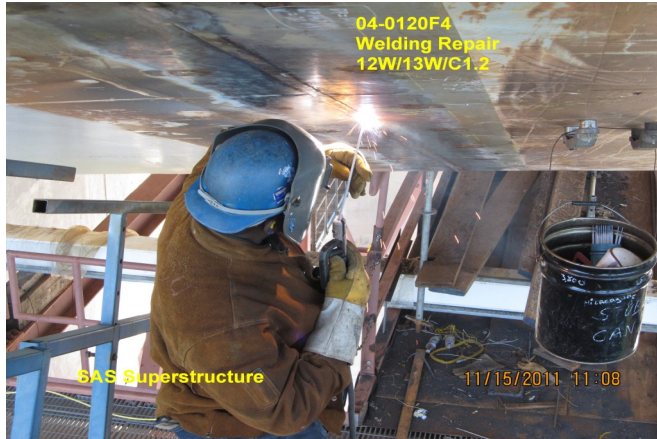
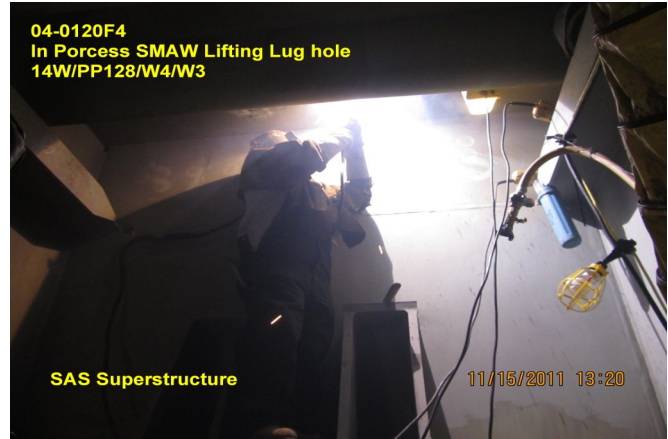
This QA Inspector randomly observed ABF welder Mike Jimenez ( ID 4671) performing the Shielded Metal Arc Welding (SMAW) process in the (4G) overhead position on “A” deck lifting lug hole 14W /PP128/W3/W4. This QA Inspector observed QC Inspector Sal Merino verify that the preheat temperature was at the minimum of 10 degrees C and that the welding parameters (Amps=270) were in accordance with ABF-WPS-D15-1110A-Revision 2. This QA Inspector made subsequent observations throughout the shift to monitor quality and noted that the work was completed on this date and appeared to be in general compliance with the contract specifications.

The QA inspector made random observations of ABF welder Jorge Lopez, ID# 6149 performing Shielded Metal Arc Welding (SMAW) in the 4G overhead position on Lifting Lug Hole W3 located at 14W/PP128/W4. The QA inspector observed QC inspector Sal Merino monitoring the progress to ensure the welding parameters was in compliance pertaining to ABF-WPS-D15-1110A-Revision 2. The parameters were recorded as (Amperes=130). The QA inspector made subsequent observations throughout the shift to monitor quality. The QA inspector noted that the work was completed on this date and appeared to be in general conformance with the contract documents.
